CAT 793D Off-Road Truck Guarded by MAG-SHIELDS®

October 2019

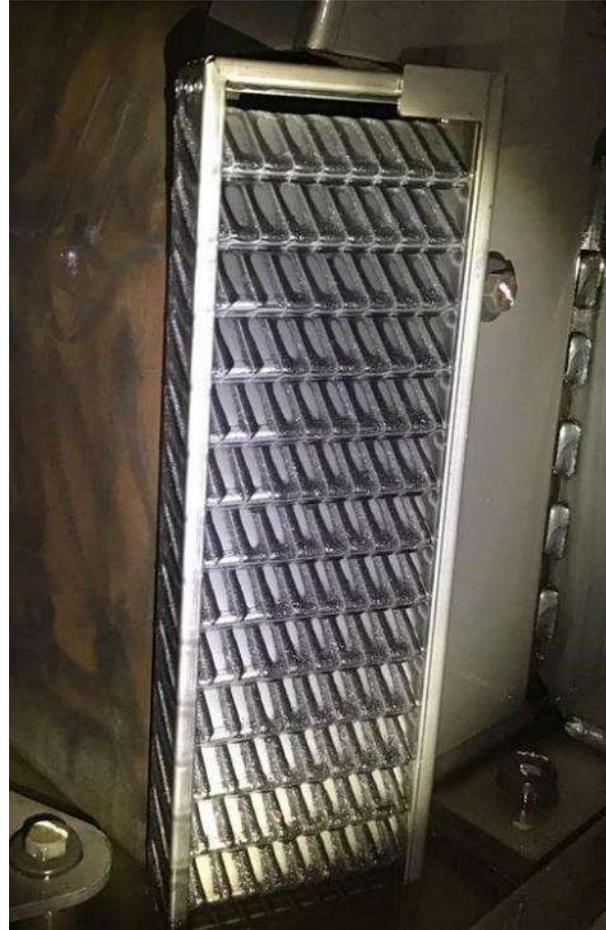
A CAT 793D off-road truck being operated at an Australian mine site had a component failure within the brake hoist hydraulic system. This type of failure would release large amounts of ferrous material contamination into the hydraulic system, which could not be contained by the factory filtration system; factory filters would plug and enter bypass, allowing unfiltered fluid to circulate within the system. This would cause additional failures to the hydraulic system, specifically damaging the pumps. Following a failure, even the most effective flushing techniques cannot remove all residual contamination. The residual contamination continues to circulate within the system and cause follow-on damage.

Despite the initial failure, additional system-wide follow-on damage was prevented due to the Mag-Shields. A paste-like coating of ferrous metal shavings had accumulated on the Mag-Shields (image, right). Had the Mag-Shields not been in

**MAG-SHIELD® installed in a
793D showing residual
contamination after component
failure and flushing**

The operators equipped this truck with a BAY6 Solutions Mag-Shield kit following the failure in the brake hoist system. The intention was to prevent follow-on failures by capturing as much residual contamination as possible. The Mag-Shields installed in the reservoir cleaned the hydraulic fluid of abrasive ferrous particles before they could recirculate through the system. Because of the design of the Mag-Shield filter, all oil must pass through the Mag-Shields before returning to circulation.

place these shavings would have circulated throughout the hydraulic system. According to site engineering **“If not for the Mag-Shields, we would have failed pumps again after the original contamination event when the Mag-Shields were installed.”** Additionally, post-failure machine cleanup is faster and more effective as the Mag-Shields can simply be removed, cleaned, and reinstalled. When combined with manufacturer recommended flushing procedures, contamination is removed more effectively and the likelihood of follow-on failures over the life of the machine is reduced. Mitigating future failures reduces downtime, improves machine reliability, and provides financial savings.
